MISCELLANEOUS PAPER EL-88-11

BIOLOGICAL AND PHYSICAL EFFECTS OF MISSOURI RIVER SPUR DIKE NOTCHING

DEPARTMENT OF THE ARMY
Waterways Experiment Station, Corps of Engineers
PO Box 631, Vicksburg, Mississippi 39181-0631

Final Report

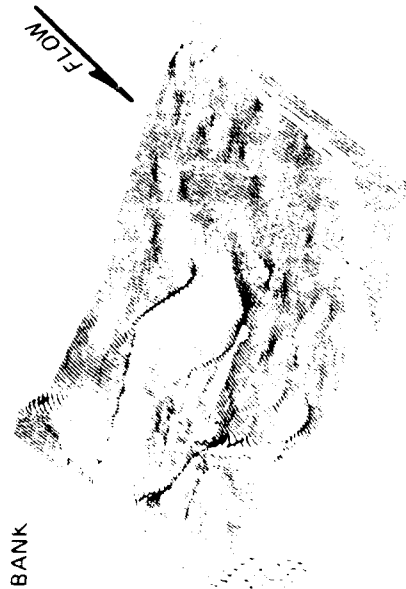
Figure A1. Three-dimensional depiction of bed topography adjacent to D729.83 and D730.0 before and after notching

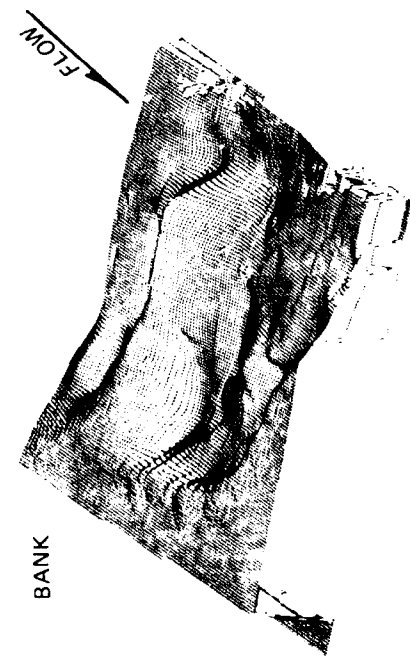
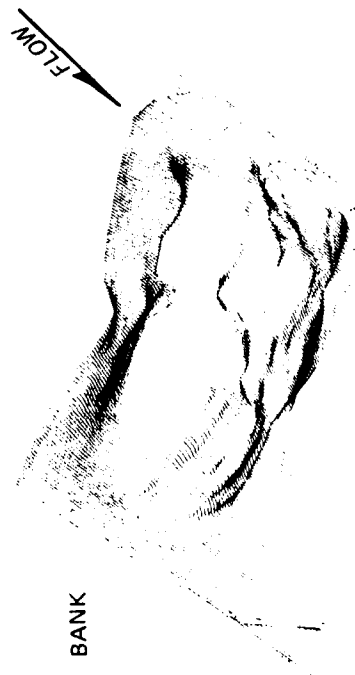
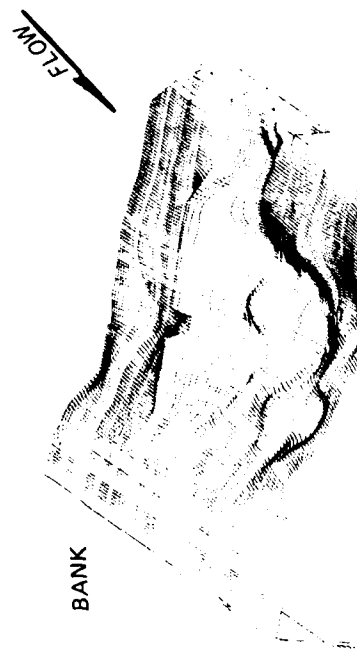
Figure A2. Three-dimensional depiction of bed topography adjacent to D605.34 and D610.20 before and after notching

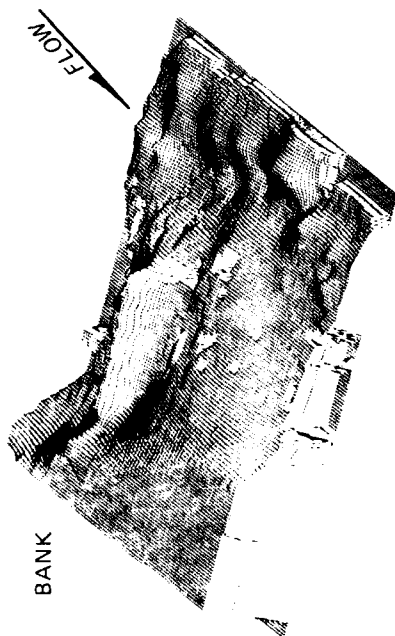
Figure A3. Three-dimensional depiction of bed topography adjacent to D616.90 and D592.55 before and after notching
